**Flood Control Project Maintenance**  
**2019 Structure Summary Report**  
**Overall Unit and Item Ratings**

**City of Sacramento**

**El Camino Avenue Bridge**

**Magpie Creek Pumping Plant**

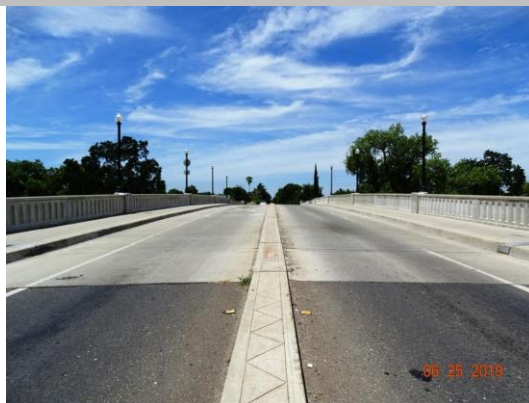
Photo 1 of 5 : ST\_2019\_NA0005\_221\_1\_20190626\_00032.jpg

View from the east end of the El Camino Bridge. Summer 2019

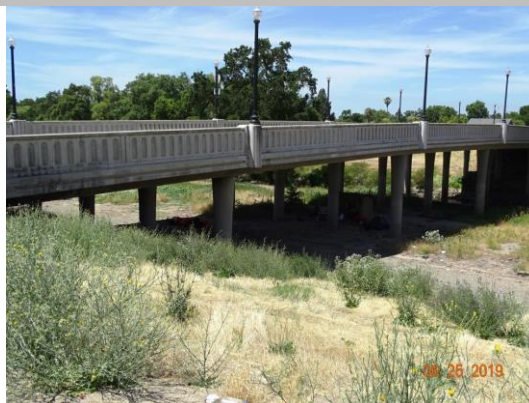
Photo 2 of 5 : ST\_2019\_NA0005\_221\_1\_20190626\_00026.jpg

View of the upstream side of the bridge from the left bank. Summer 2019

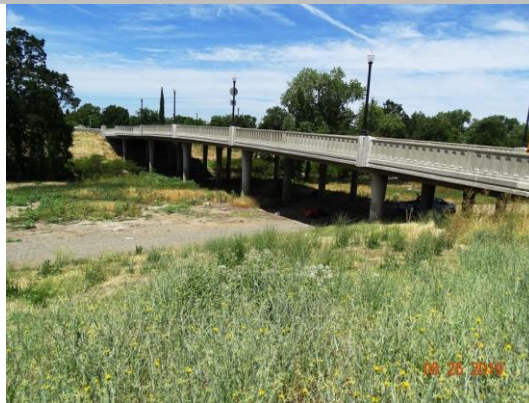
Photo 3 of 5 : ST\_2019\_NA0005\_221\_1\_20190626\_00031.jpg

View of the downstream side of the bridge from the left bank. Summer 2019

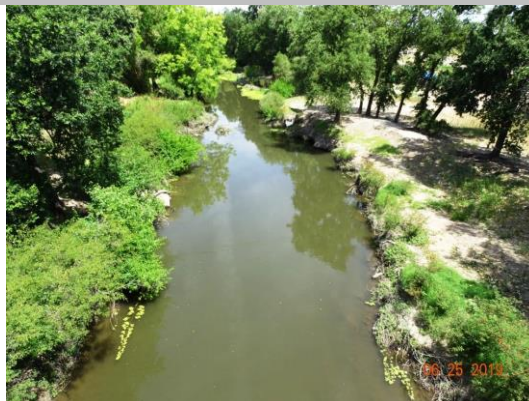
Photo 1 of 3 : ST\_2019\_NA0005\_221\_2\_20190626\_00035.jpg

LM Start	0.00	Rating **	A	Issue No.	2
LM End	0.00	Issue Type +	Ma	Location *	WS
Category	Structures & Concrete Lined Channels			GPS Latitude/Longitude	
				Start	End
Item	Vegetation & Obstructions			38.611365 °	38.611365 °
				-121.466557 °	-121.466557 °
DWR ID	DWR_NA0005_221_t_2012_2				
Action/Comments					
Inspector Comments: The channel appeared to be free of any vegetation growth that would impede flows.

View of upstream vegetation. Summer 2019

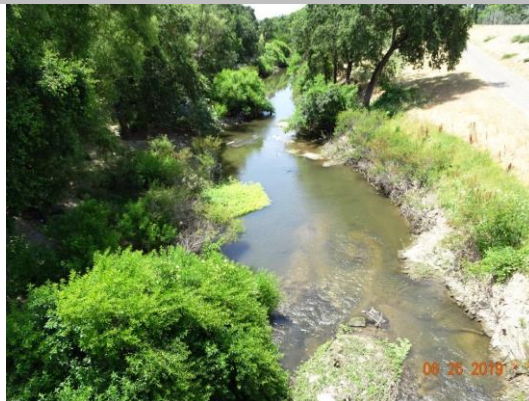
Photo 2 of 3 : ST\_2019\_NA0005\_221\_2\_20190626\_00034.jpg

LM Start	0.00	Rating **	A	Issue No.	2 (cont)	
LM End	0.00	Issue Type +	Ma	Location *	WS	
Category	Structures & Concrete Lined Channels			GPS Latitude/Longitude		
				Start		End
Item	Vegetation & Obstructions			38.611365 °		38.611365 °
				-121.466557 °		-121.466557 °
DWR ID	DWR_NA0005_221_t_2012_2					
Action/Comments						
Inspector Comments: The channel appeared to be free of any vegetation growth that would impede flows.

View of downstream vegetation. Summer 2019

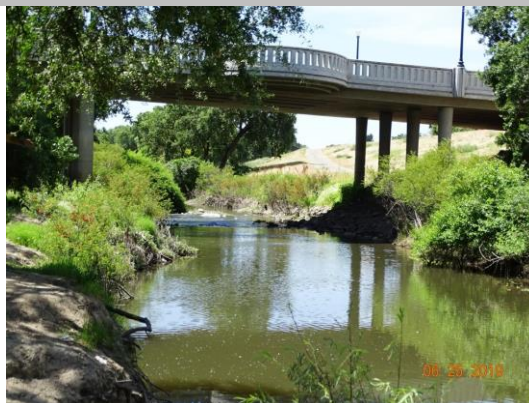
Photo 3 of 3 : ST\_2019\_NA0005\_221\_2\_20190627\_00036.jpg

View of the channel under the bridge looking downstream. Summer 2019

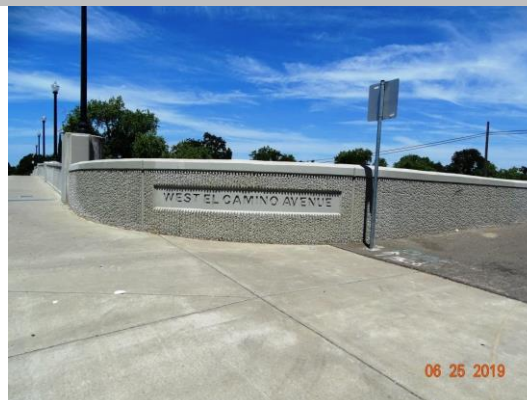
Photo 1 of 8 : ST\_2019\_NA0005\_221\_22\_20190627\_00044.jpg

View of the northeast flood wall with monolith joints. Summer 2019

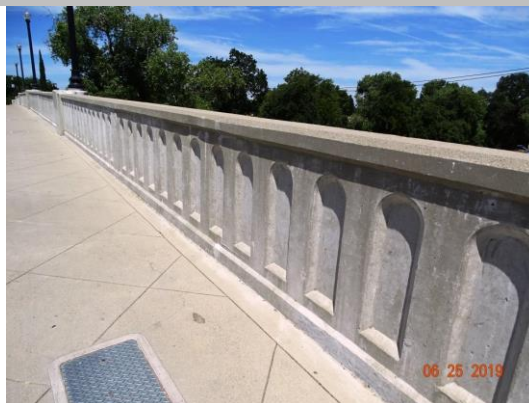
Photo 2 of 8 : ST\_2019\_NA0005\_221\_22\_20190627\_00045.jpg

View of the northeast flood wall with monolith joints. Summer 2019

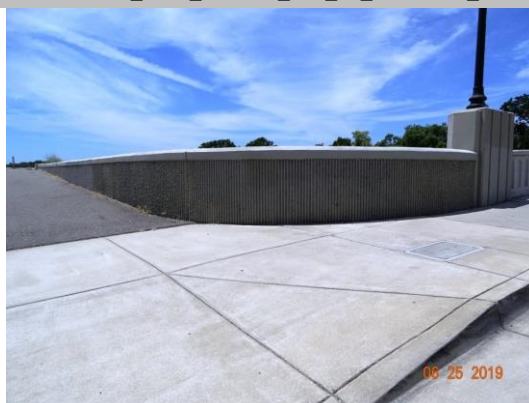
Photo 3 of 8 : ST\_2019\_NA0005\_221\_22\_20190627\_00053.jpg

View of the southeast flood wall with monolith joints. Summer 2019

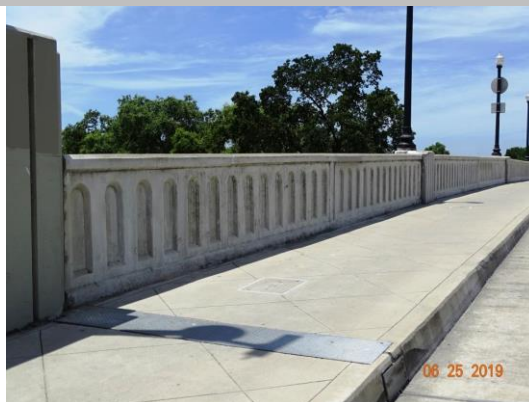
Photo 4 of 8 : ST\_2019\_NA0005\_221\_22\_20190627\_00054.jpg

View of the southeast flood wall with monolith joints. Summer 2019

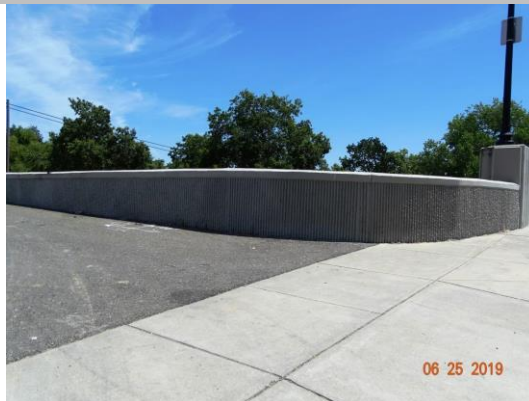
Photo 5 of 8 : ST\_2019\_NA0005\_221\_22\_20190627\_00048.jpg

View of the northwest flood wall with monolith joints. Summer 2019

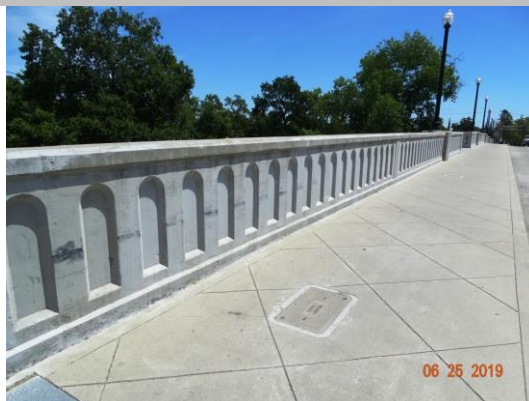
Photo 6 of 8 : ST\_2019\_NA0005\_221\_22\_20190627\_00049.jpg

View of the northwest flood wall with monolith joints. Summer 2019

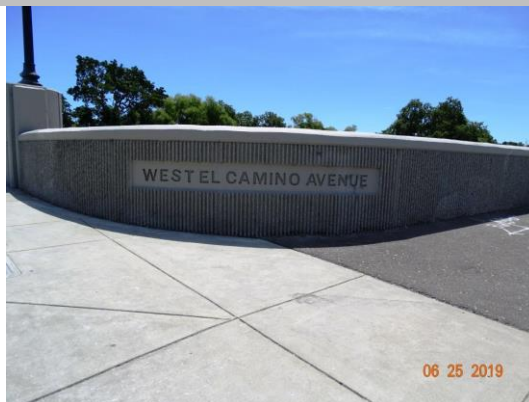
Photo 7 of 8 : ST\_2019\_NA0005\_221\_22\_20190627\_00050.jpg

View of the southwest flood wall with monolith joints. Summer 2019

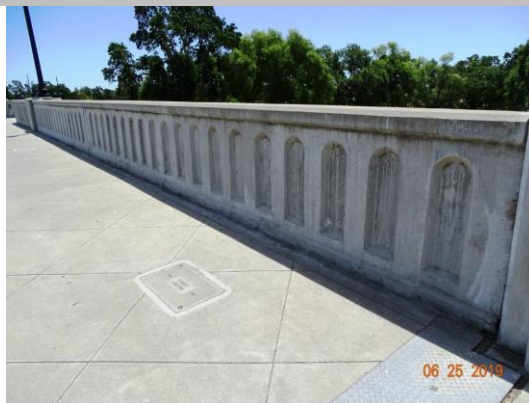
Photo 8 of 8 : ST\_2019\_NA0005\_221\_22\_20190627\_00051.jpg

View of the southwest flood wall with monolith joints. Summer 2019

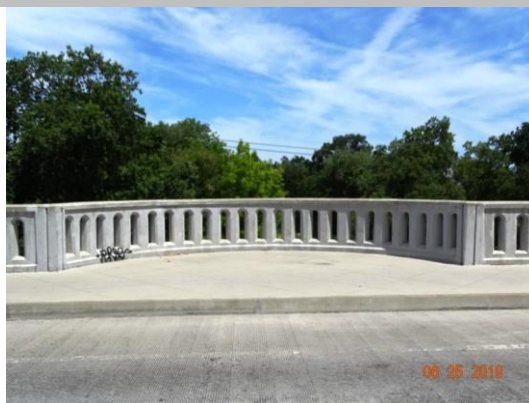
Photo 1 of 2 : ST\_2019\_NA0005\_221\_23\_20190627\_00058.jpg

View of the north guard rails. Summer 2019

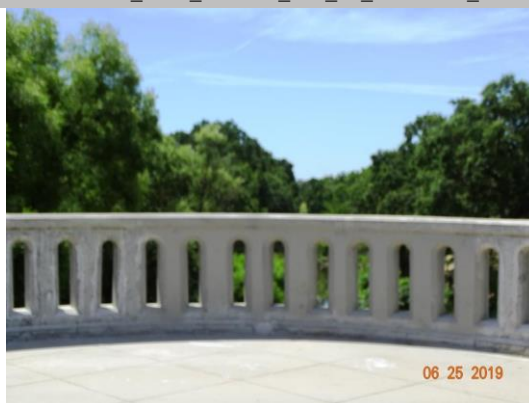
Photo 2 of 2 : ST\_2019\_NA0005\_221\_23\_20190627\_00057.jpg

View of the south guard rails. Summer 2019

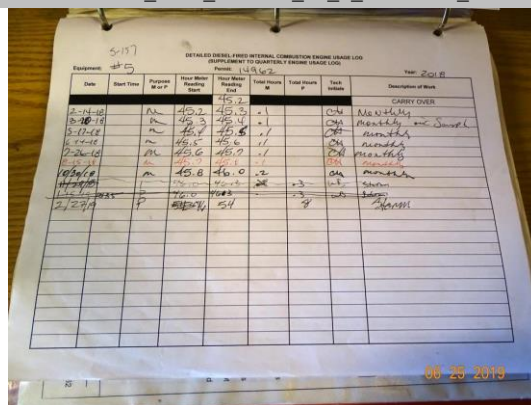
Photo 1 of 1 : ST\_2019\_NA0005\_16\_1\_20190625\_00030.jpg

LM Start	0.00	Rating **	A	Issue No.	1
LM End	0.00	Issue Type +	Ma	Location *	
Category	Pump Stations			GPS Latitude/Longitude	
				Start	End
Item	Operating Log			38.640967 °	38.640967 °
				-121.471106 °	-121.471106 °
DWR ID	DWR_NA0005_16_t_2012_1				
Action/Comments					
Inspector Comments: The operation log shows preventive maintenance activities for the engines, and the maintenance records show activities following their prescribed frequencies.

View of the operating log for the diesel engines at the station. Summer 2019

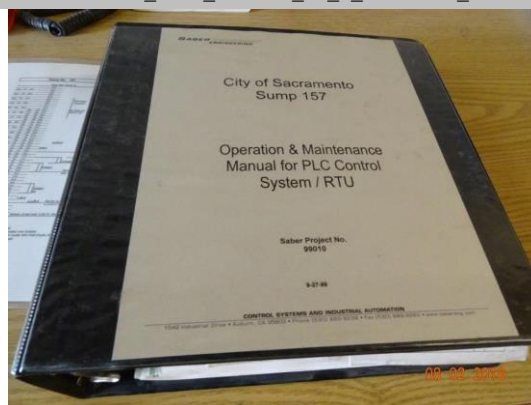
Photo 1 of 2 : ST\_2019\_NA0005\_16\_2\_20190619\_00002.jpg

View of the O&amp;M manual for the PLC Control System/RTU. Summer 2018

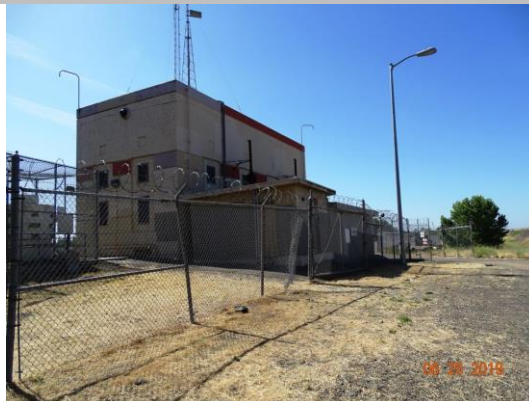
Photo 1 of 2 : ST\_2019\_NA0005\_16\_3\_20190625\_00031.jpg

View of the pumping plant looking southeast. Summer 2019

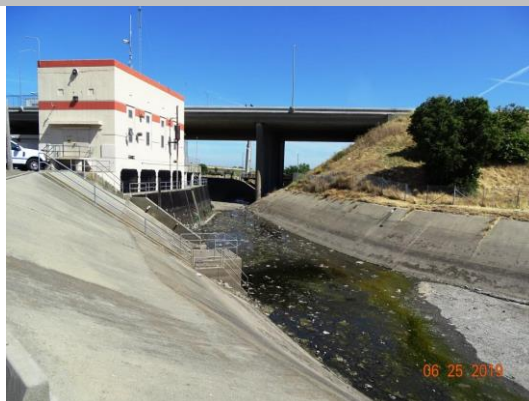
Photo 2 of 2 : ST\_2019\_NA0005\_16\_3\_20190625\_00032.jpg

View of the pumping plant looking northwest. Summer 2019

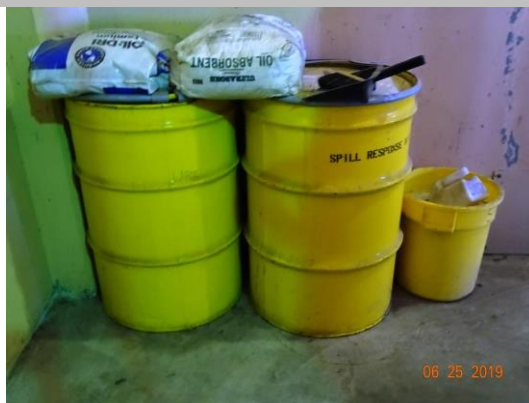
Photo 2 of 5 : ST\_2019\_NA0005\_16\_5\_20190625\_00035.jpg

View of emergency spill kit inside the pump room. Summer 2019

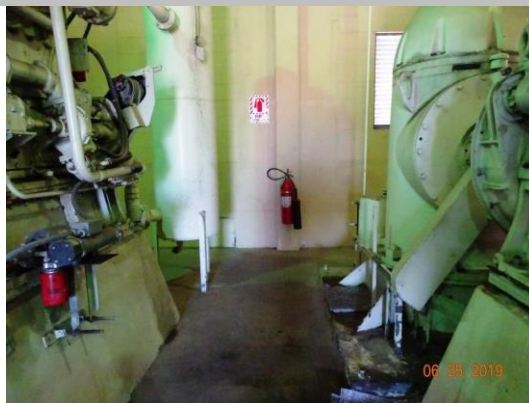
Photo 3 of 5 : ST\_2019\_NA0005\_16\_5\_20190625\_00034.jpg

View of one of the fire extinguishers inside the pump room. Summer 2019

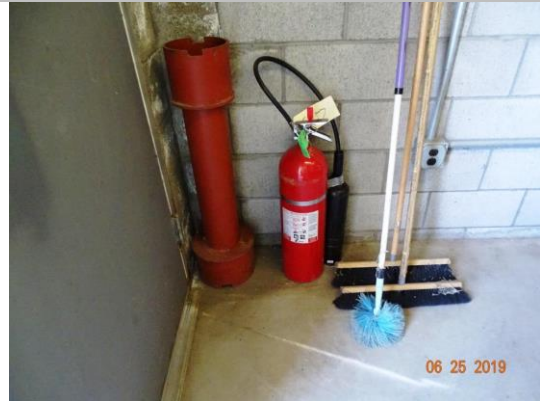
Photo 4 of 5 : ST\_2019\_NA0005\_16\_5\_20190625\_00033.jpg

View of one of the fire extinguishers inside the motor control room.  
Summer 2019

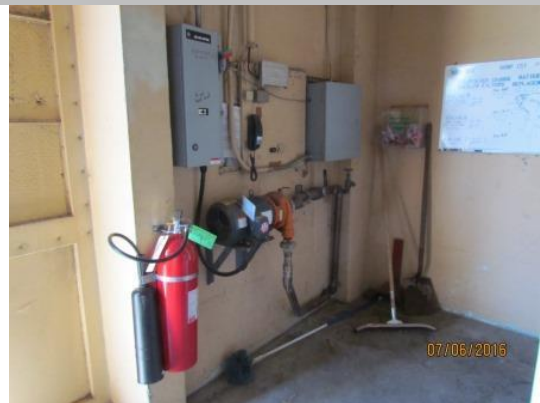
Photo 5 of 5 : ST\_2019\_NA0005\_16\_5\_20190619\_00007.jpg

View of one of the fire extinguishers inside the pump room. Summer 2017

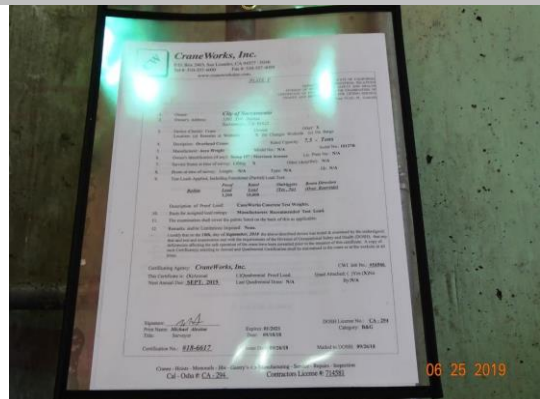
Photo 1 of 2 : ST\_2019\_NA0005\_16\_6\_20190626\_00036.jpg

LM Start	0.00	Rating **	A	Issue No.	6
LM End	0.00	Issue Type +	Ma	Location *	
Category	Pump Stations			GPS Latitude/Longitude	
				Start	End
Item	Cranes			38.640967 °	38.640967 °
				-121.471106 °	-121.471106 °
DWR ID	DWR_NA0005_16_t_2012_6				
Action/Comments					
Inspector Comments: Hoist and monorail system was tested and appear to be functional. Annual CAL/OSHA Crane Certification completed.

View of the annual certification. Summer 2019

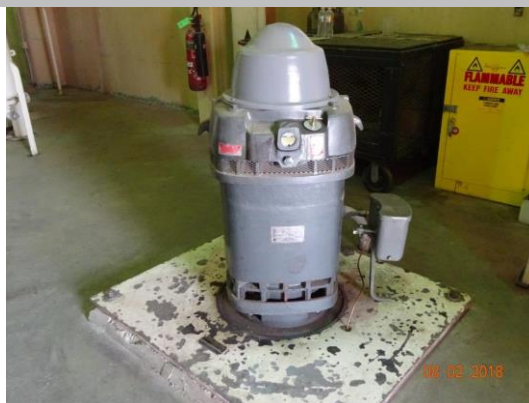
Photo 1 of 5 : ST\_2019\_NA0005\_16\_7\_20190619\_00009.jpg

LM Start	0.00	Rating **	A	Issue No.	7	
LM End	0.00	Issue Type +	Ma	Location *		
Category	Pump Stations			GPS Latitude/Longitude		
				Start	End	
Item	Pumps			38.640967 °	38.640967 °	
				-121.471106 °	-121.471106 °	
DWR ID	DWR_NA0005_16_t_2012_7					
Action/Comments						
Inspector Comments: All pumps are available and in service.

View of small electric pump. Summer 2018

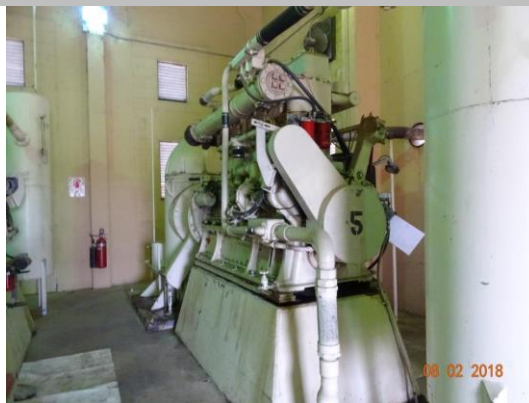
Photo 2 of 5 : ST\_2019\_NA0005\_16\_7\_20190619\_00010.jpg

View of propane-powered pump 5. Summer 2018

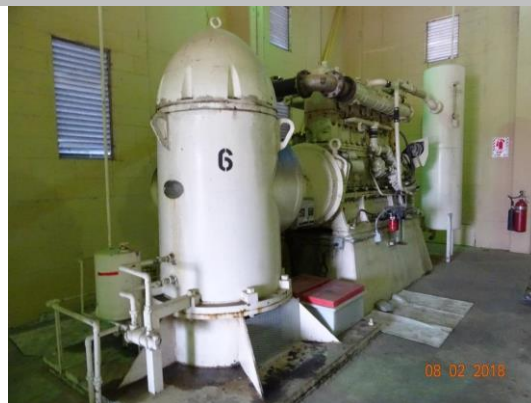
Photo 3 of 5 : ST\_2019\_NA0005\_16\_7\_20190619\_00011.jpg

View of propane-powered pump 6. Summer 2018

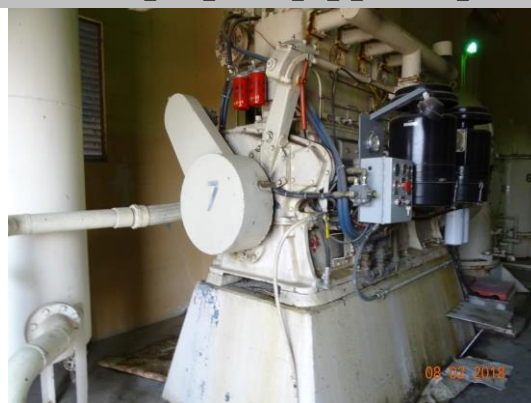
Photo 4 of 5 : ST\_2019\_NA0005\_16\_7\_20190619\_00012.jpg

View of propane-powered pump 7. Summer 2018

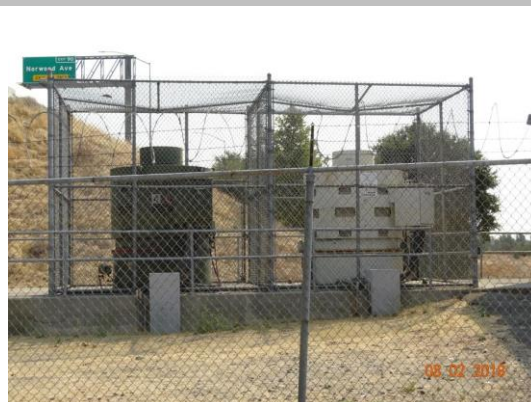
Photo 5 of 5 : ST\_2019\_NA0005\_16\_7\_20190619\_00013.jpg

View of electric pumps located north of the pump building. Summer 2018

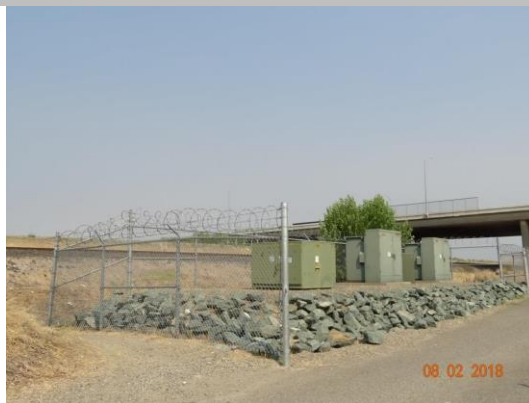
Photo 1 of 2 : ST\_2019\_NA0005\_16\_8\_20190619\_00014.jpg

View of the electric power sources located south of the pump building.  
Summer 2018

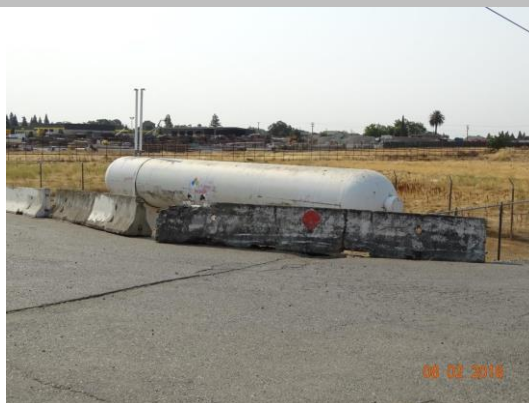
Photo 2 of 2 : ST\_2019\_NA0005\_16\_8\_20190619\_00015.jpg

View of the propane tank located south of the pump building. Summer 2018

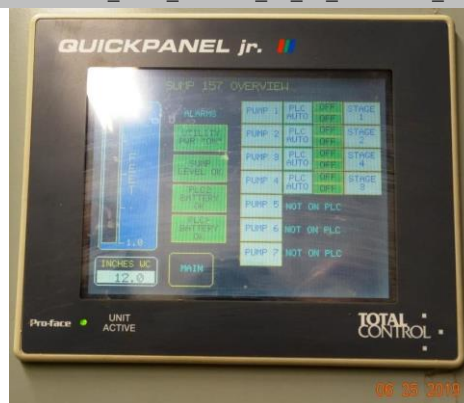
Photo 1 of 3 : ST\_2019\_NA0005\_16\_11\_20190626\_00039.jpg

View of pump control interface. Summer 2019

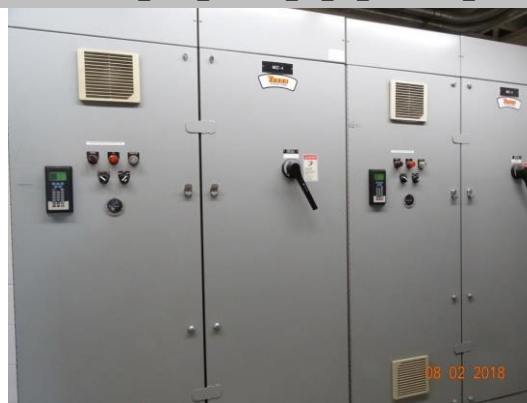
Photo 2 of 3 : ST\_2019\_NA0005\_16\_11\_20190619\_00018.jpg

View of the motor control center. Summer 2018

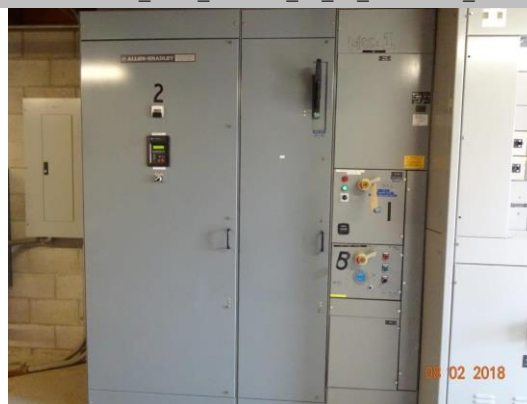
Photo 3 of 3 : ST\_2019\_NA0005\_16\_11\_20190619\_00019.jpg

View of the motor control center. Summer 2018

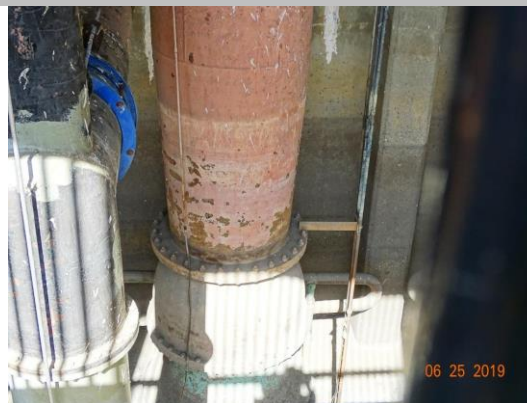
Photo 1 of 2 : ST\_2019\_NA0005\_16\_12\_20190626\_00040.jpg

View of the wetwell. Summer 2019

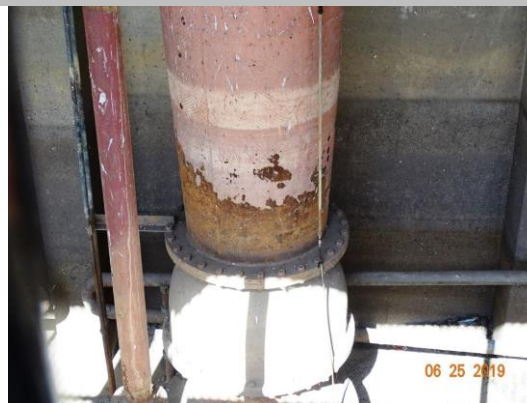
Photo 2 of 2 : ST\_2019\_NA0005\_16\_12\_20190626\_00041.jpg

View of the wetwell. Summer 2019

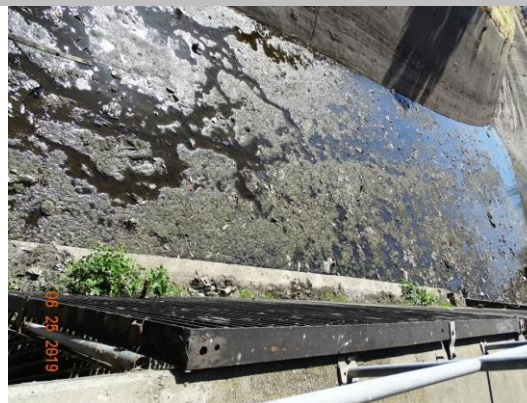
Photo 1 of 1 : ST\_2019\_NA0005\_16\_13\_20190626\_00042.jpg

View of the trash racks. Summer 2019

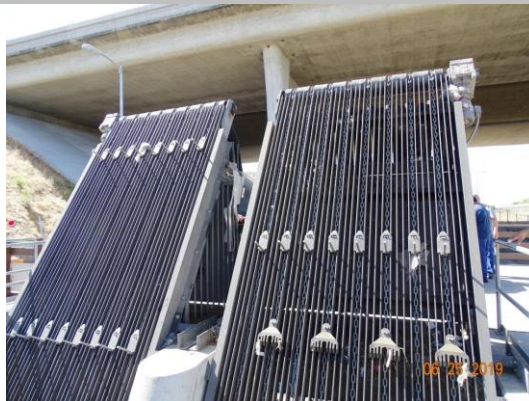
Photo 1 of 2 : ST\_2019\_NA0005\_16\_14\_20190626\_00043.jpg

LM Start	0.00	Rating **	A	Issue No.	14
LM End	0.00	Issue Type +	Ma	Location *	
Category	Pump Stations			GPS Latitude/Longitude	
				Start	End
Item	Trash Rakes			38.640967 °	38.640967 °
				-121.471106 °	-121.471106 °
DWR ID	DWR_NA0005_16_t_2012_14				
Action/Comments					
Inspector Comments: Both Duperon screens appear to be running properly.

View of the Duperon trash rakes. Summer 2019

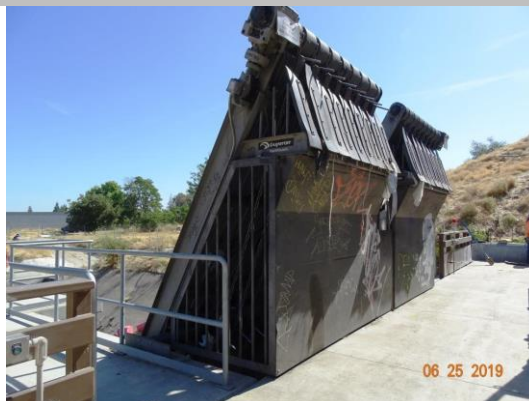
Photo 2 of 2 : ST\_2019\_NA0005\_16\_14\_20190626\_00044.jpg

View of the Duperon trash rakes. Summer 2019

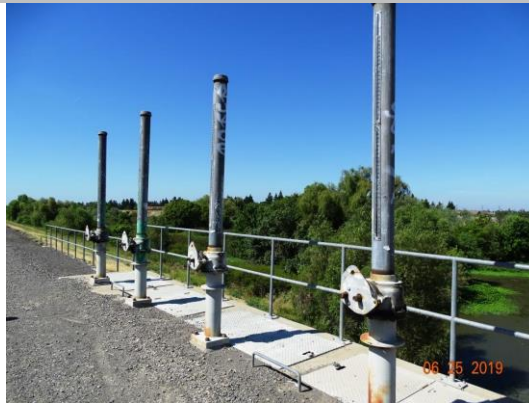
Photo 1 of 1 : ST\_2019\_NA0005\_16\_9\_20190626\_00038.jpg

View of manually operated sluice gates. Summer 2019

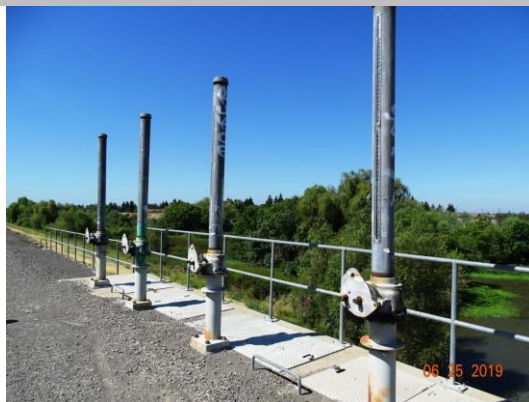
Photo 1 of 1 : ST\_2019\_NA0005\_16\_17\_20190626\_00045.jpg

View of the manual gate operators. A hydraulic wrench is centrally stored at another facility. Summer 2019

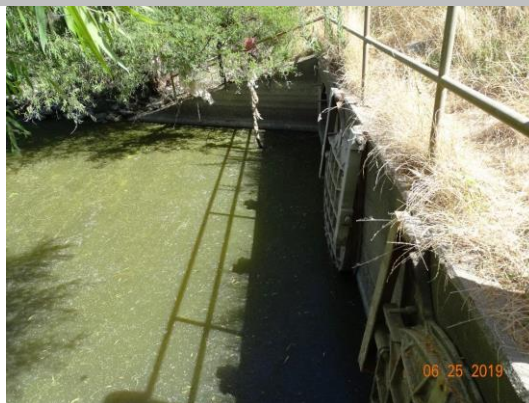
Photo 1 of 2 : ST\_2019\_NA0005\_16\_19\_20190626\_00047.jpg

View of the flap gates to the north. Summer 2019

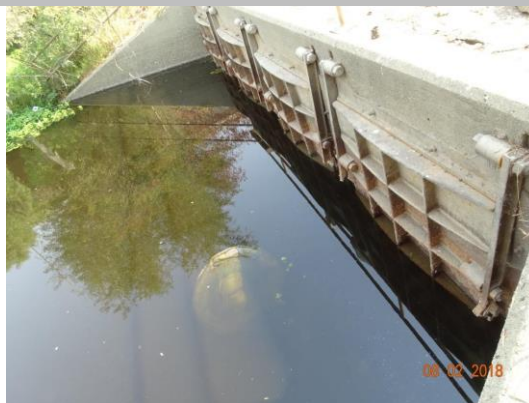
Photo 2 of 2 : ST\_2019\_NA0005\_16\_19\_20190619\_00025.jpg

View of the flap gates to the south. Summer 2018

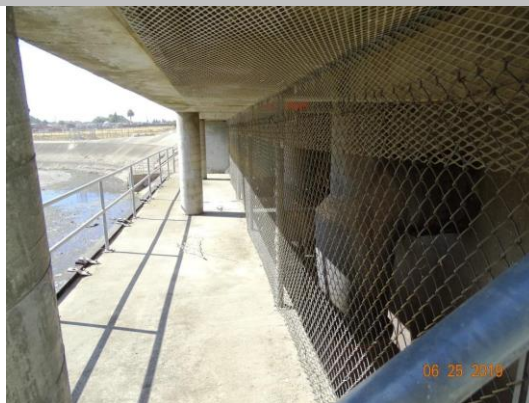
Photo 1 of 3 : ST\_2019\_NA0005\_16\_22\_20190626\_00053.jpg

View of intake pipes. Summer 2019

LM Start	0.00	Rating **	A	Issue No.	22
LM End	0.00	Issue Type +	Ma	Location *	
Category	Pump Stations			GPS Latitude/Longitude	
				Start	End
Item	Intake and Discharge Pipes			38.640967°	38.640967°
				-121.471106°	-121.471106°
DWR ID	DWR_NA0005_16_t_2012_22				
Action/Comments					
Inspector Comments: Repair and secure grate over discharge pipes.

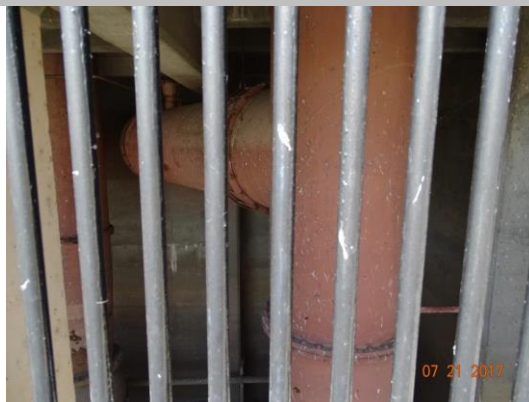
Photo 3 of 3 : ST\_2019\_NA0005\_16\_22\_20190619\_00029.jpg

View of another intake pipe. Summer 2017
